## **Wheeler Road Gate House Lightning Strike 10/27/2007**

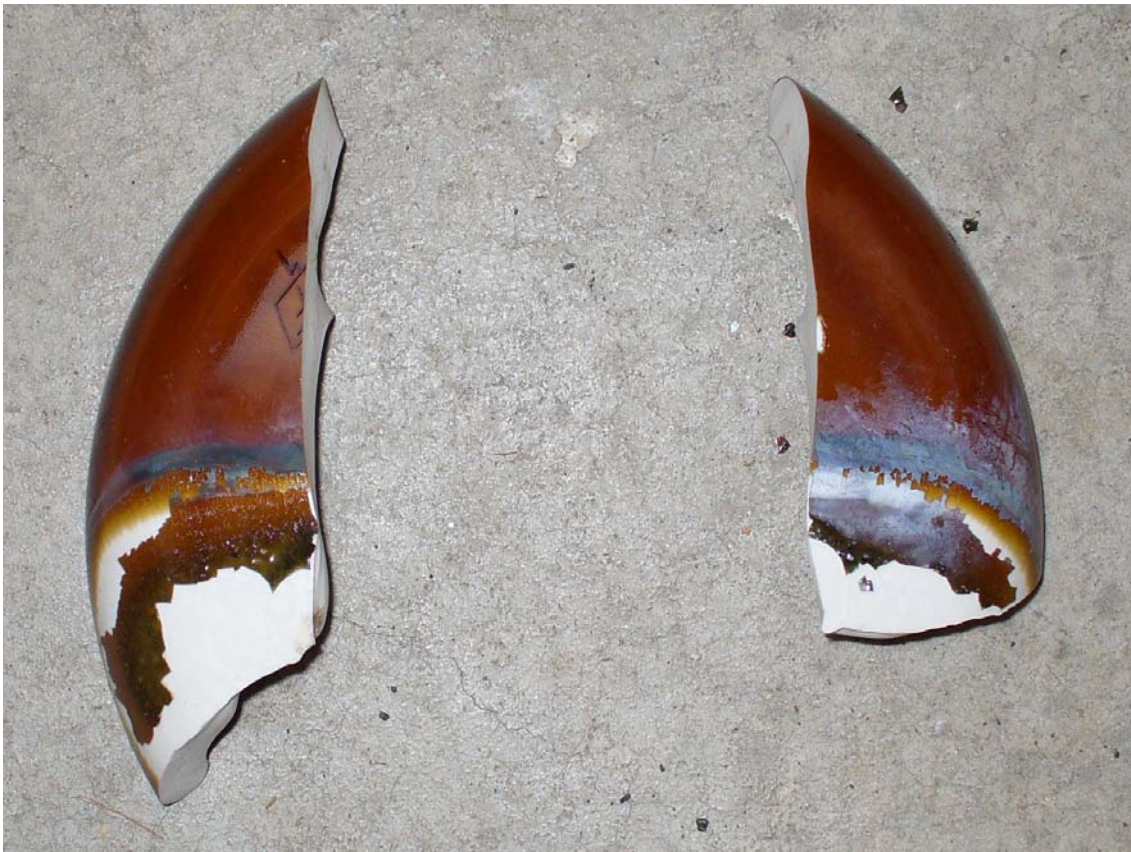
- 1) An insulator shattered that supported a primary wire adjacent to the utility transformer supplying power to our gate. Note the scorch marks on the insulator fragments suggesting this may have been the primary strike point.

**Shattered Insulator**

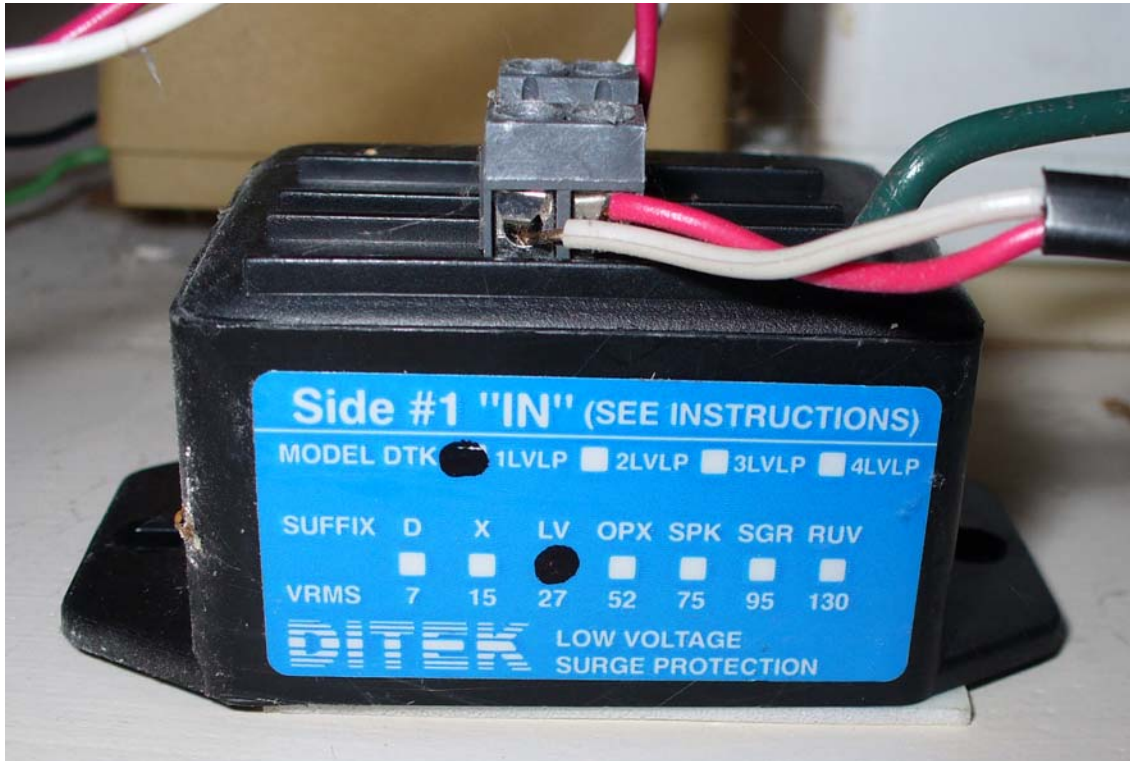
- 3) The class 2 plug-in power transformer supplying power to the Entry Panel failed. A Low Voltage Surge Suppressor is connected between the secondary of the transformer and the load (Entry Panel) that does not appear to be damaged.

**Low Voltage Surge Suppressor**

- 2) Plug the gate control electronics and surveillance components into a Surge Suppressor/Power Strip with a surge absorption rating of greater than 3500 joules.

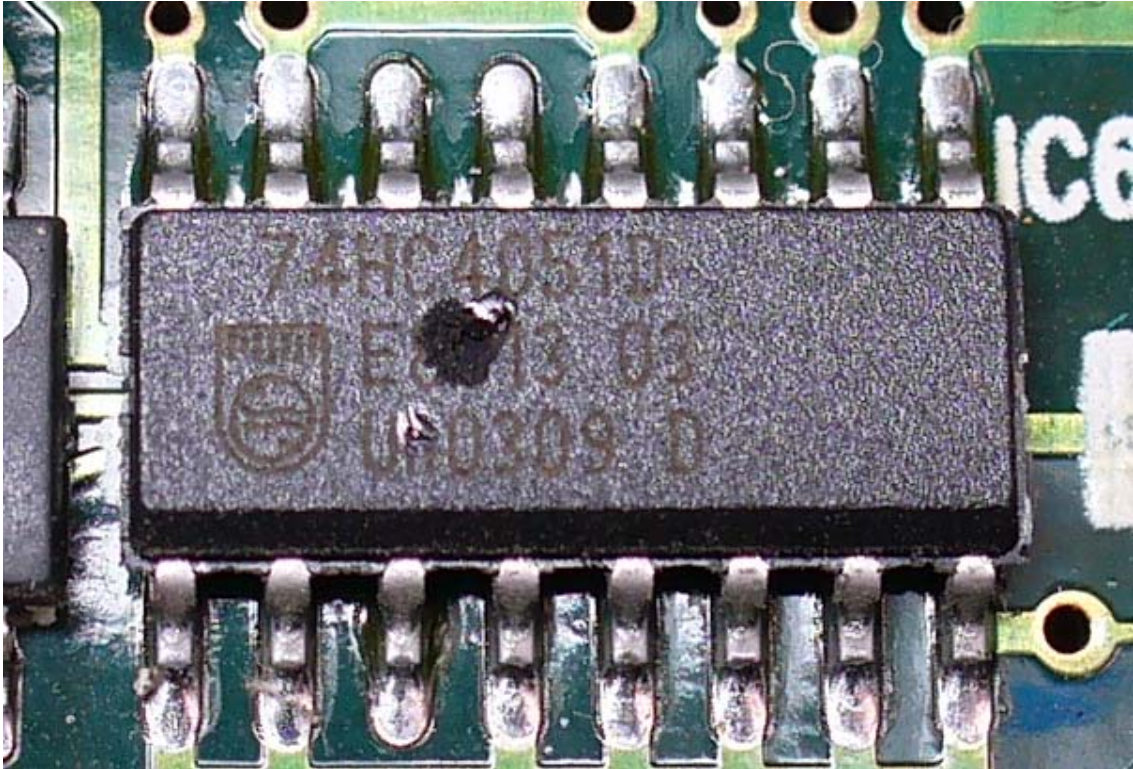
- 4) The Entry Panel main board failed. Entry panel: DoorKing 1815, Version 22. No failure analysis was performed.
- 5) The Card Reader failed. No failure analysis was performed.
- 6) The radio receiver for remotes failed. No failure analysis was performed. As a result it is not known if the surge voltage entered through the antenna connector or power supply terminals.
- 7) The DVR failed. Failure analysis reveals that a 74HC4051 CMOS bilateral switch connected to the Video Input and Output failed explosively. This indicates that the surge voltage likely entered through the Video Input and/or Output connector(s). Due to cable routing and exposures, it is likely the surge entered the Video Input connector. The remainder of the circuitry appears undamaged and functioning.

**Damage to DVR component**

- 7) Provide a 10 Gauge or larger copper wire for grounding the soon to be installed rear entry camera.
- 8) Provide 10 Gauge or larger copper wires for grounding future front and rear exit cameras.
