Inspection Report for
Odd Fellow Sierra Recreation Association
Long Barn, CA

13 KG Steel on Grade
Tank #1

Date Completed: July 4th, 2010

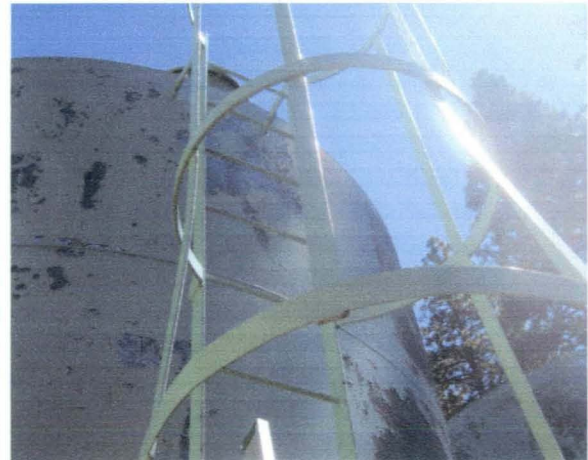
Access Ladder Condition

Ladder Type: Steel
 Coating Condition: Good
 Corrosion Present? Y N
 Seams/Welds Condition: Excellent
 Oxidation Present? Y N
 De-lamination Present? Y N
 Stand Off Supports Condition: Excellent
 Safety Climb Type: Cage
 Safety Climb Condition: Excellent
 Is top of tank easily accessible? Y N
 Is the ladder and Safety Climb OSHA approved? Y N

Summary: The ladder was found secure, OSHA approved and in excellent to good condition with corrosion noted.

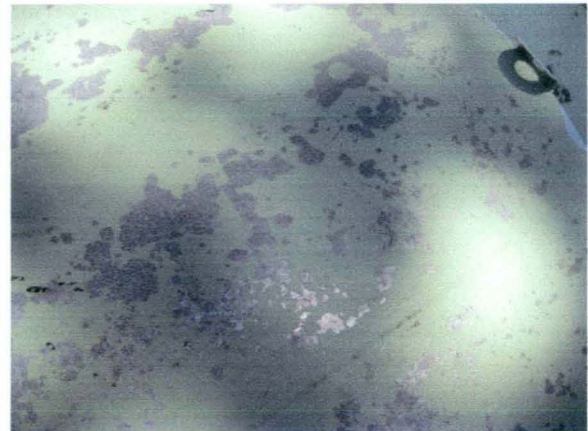
Roof Condition

Coating Condition: Fair/Poor
 Corrosion Present? Y N
 Percentage: N/A
 Seams/Welds Condition: Excellent
 Oxidation Present? Y N
 De-lamination Present? Y N
 Low Spots Present? Y N
 Holes in Roof? Y N
 Cathodic Protection Plates Present? Y N
 Sealed Edges: Y N NA
 Loose Plates? Y N NA
 Missing Plates? Y N NA

Summary: The roof was found in fair to poor condition with de-lamination noted. Recommend re-coating the roof.

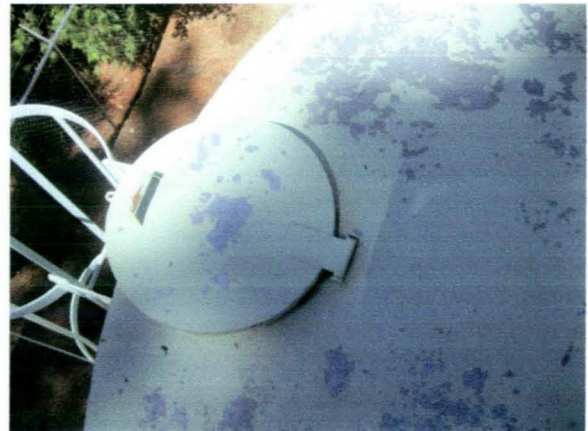
Access Hatch Condition

Coating Condition: Fair/Poor
 Corrosion Present: Y N
 Seams/Welds Condition: Excellent
 Oxidation Present? Y N
 De-lamination Present? Y N
 Hatch Size: 18 inch round
 Hatch Locked? Y N
 Hinge Condition: Good
 Gasket Present? Y N
 Intact? Y N NA
 Insects, dirt or debris present under hatch? Y N

Summary: The hatch was found locked with no gasket present and in good condition with corrosion and de-lamination noted. Recommend installing a gasket and re-coating.

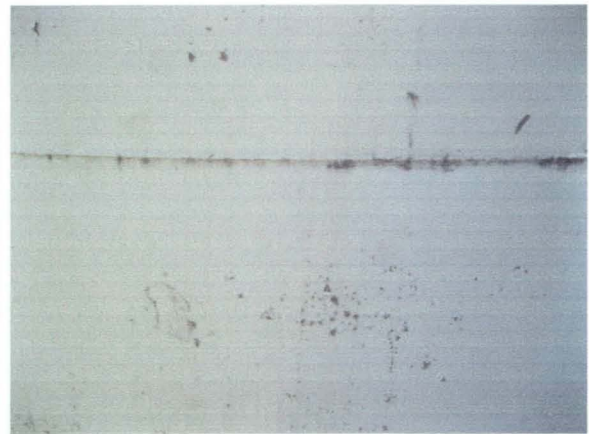
Wall Panel Condition

Coating Condition: Fair/Poor
Corrosion Present? Y N
Percentage: N/A
Seams/Welds Condition: Excellent
Oxidation Present? Y N
De-lamination Present? Y N
Dents Present? Y N
Holes Present? Y N

Summary: The walls were found in fair to poor condition with 50% de-lamination noted. Recommend re-coating the wall panels.

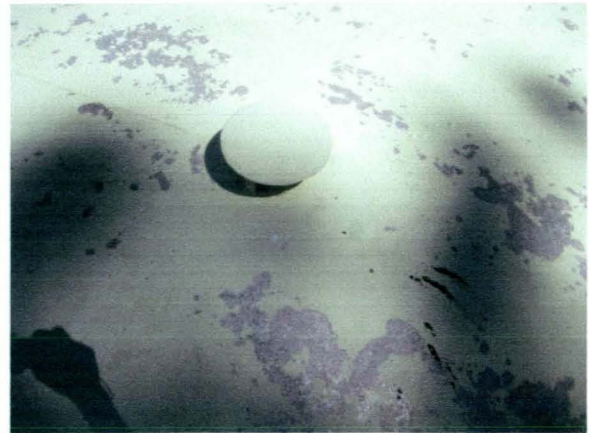
Vent Condition

Coating Condition: Good
Corrosion Present: Y N
Percentage: 5%
Seams/Welds Condition: Good
Oxidation Present? Y N
De-lamination Present? Y N
Screen in Place? Y N
Condition: Good
All Openings sealed? Y N
Cap Condition: Good

Summary: The vent was found in good condition with a screen in place and corrosion noted.

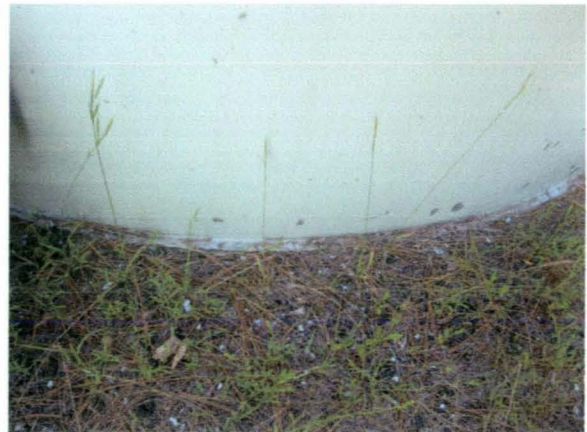
Foundation Condition

Foundation Exposed? Y N
Anchor Bolts Present? Y N
Corrosion on Anchor Bolts Present? Y N NA
Anchor Bolts Loose? Y N NA
Cracking Noted in Foundation? Y N NA
Spalling Noted? Y N

Summary: The foundation was found in excellent condition.

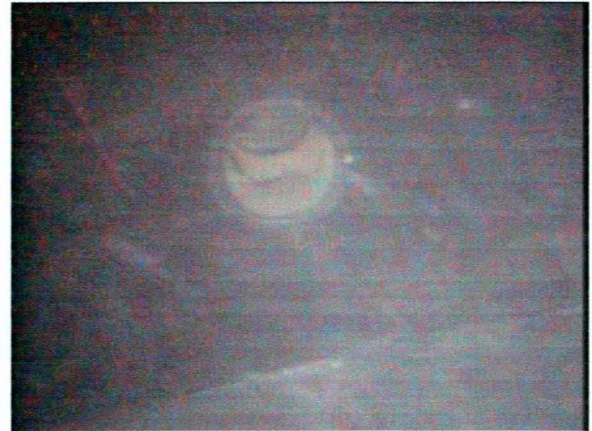
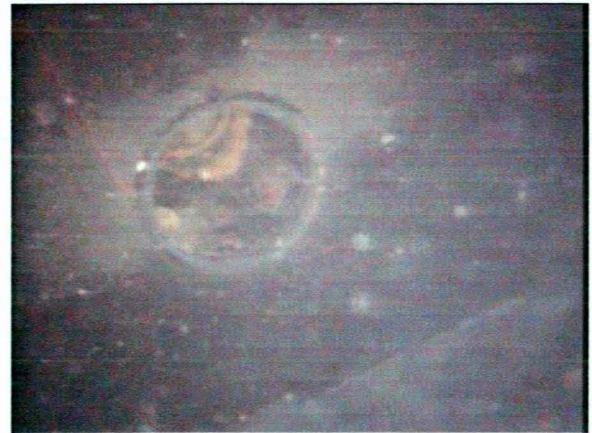
Inlet and Outlet Condition

Summary: The inlet and outlet were found in good condition.

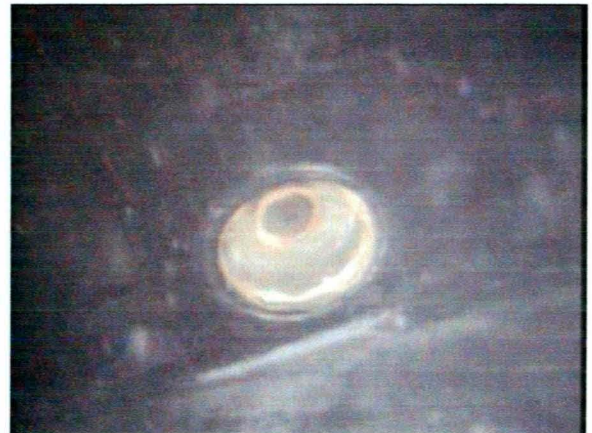
Drain Condition

Summary: The drain was found in good condition with corrosion noted.

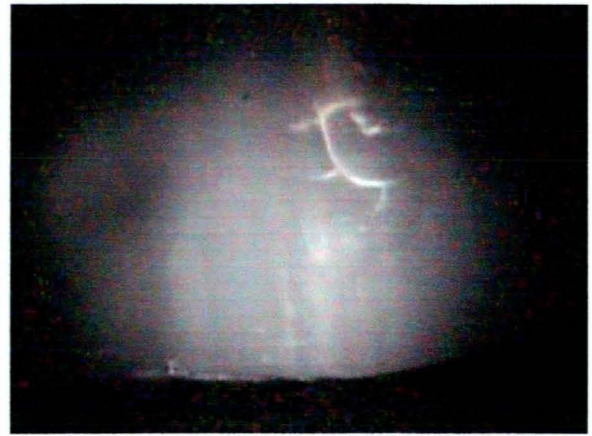
Wall Panel Condition

Coating Condition: Excellent/Good
Welds/seam condition: Excellent
Corrosion Present on panel? Y N
Percentage: N/A
Pitting noted in metal? Y N
Depth: N/A

Summary: The walls were found in excellent to good condition.
Between ¼ and ½ inch of manganese sediment was removed.

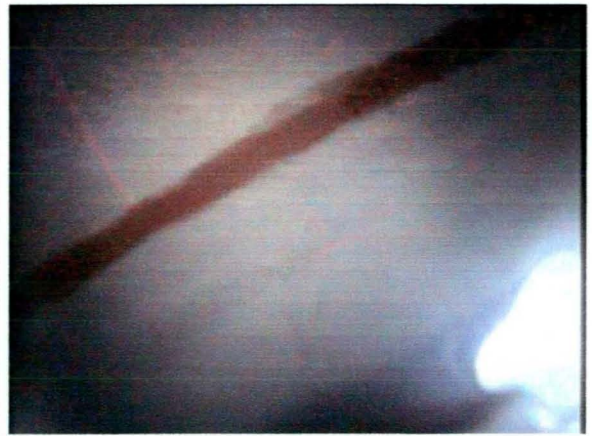
Roof Condition

Coating Condition: Good
Welds/seam condition: Good
Corrosion Present on panels? Y N
Percentage: N/A
Metal De-alloying noted? Y N
Percentage: N/A

Summary: The roof was found in good condition.

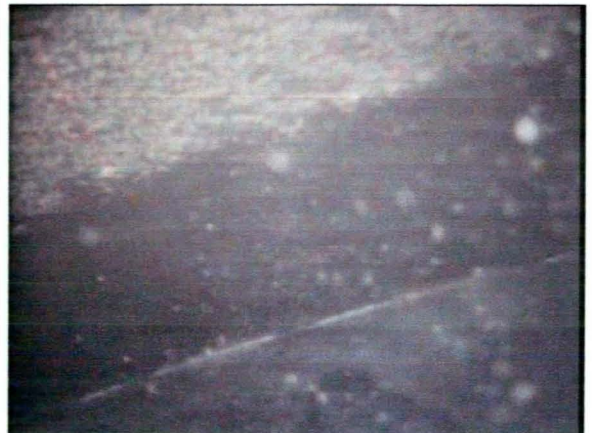
Floor Condition

Coating Condition: Good
Welds/seam condition: Good
Corrosion Present? Y N
Percentage: N/A
Pitting noted in metal? Y N
Depth: N/A

Summary: The floor was found in good condition.
Approximately 4 inches of manganese sediment was removed.
