Inspection Report for
Odd Fellow Sierra Recreation Association
Long Barn, CA

13 KG Steel on Grade
Tank #3

Date Completed: July 4th, 2010

Exterior Inspection Report

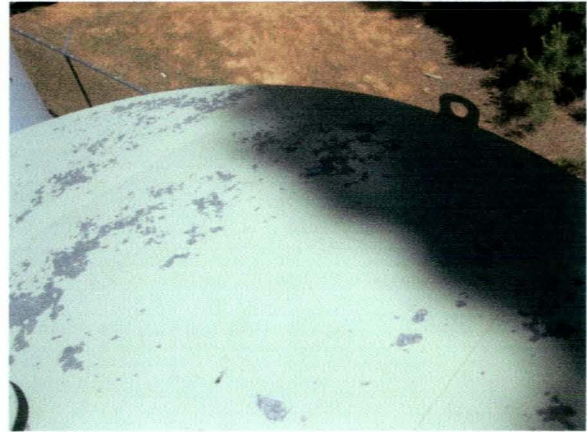
Roof Condition

Coating Condition: Fair/Poor
 Corrosion Present? Y N
 Percentage: N/A
 Seams/Welds Condition: Excellent
 Oxidation Present? Y N
 De-lamination Present? Y N
 Low Spots Present? Y N
 Holes in Roof? Y N
 Cathodic Protection Plates Present? Y N
 Sealed Edges: Y N NA
 Loose Plates? Y N NA
 Missing Plates? Y N NA

Summary: The roof was found in fair to poor condition with de-lamination noted. Recommend recoating.

1. Install a gasket on the access hatch.
2. Schedule time to repaint the exterior of the tank.
3. Clean and inspect every 3-5 years per AWWA recommendations.

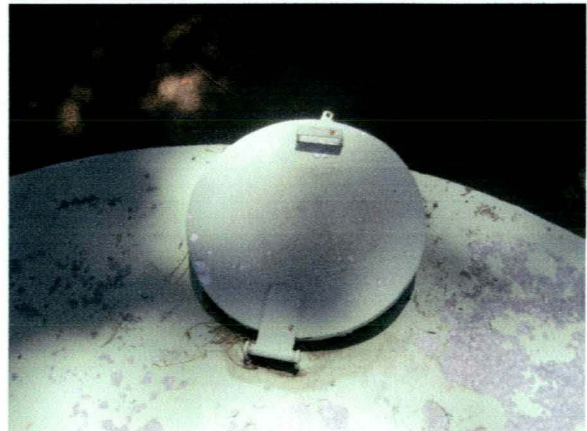
Access Hatch Condition

Coating Condition: Fair/Poor
 Corrosion Present: Y N
 Seams/Welds Condition: Excellent
 Oxidation Present? Y N
 De-lamination Present? Y N
 Hatch Size: 18 inch round
 Hatch Locked? Y N
 Hinge Condition: Good
 Gasket Present? Y N
 Intact? Y N NA
 Insects, dirt or debris present under hatch? Y N

Summary: The hatch was found locked with no gasket present and in good condition with corrosion and de-lamination noted. Recommend installing a gasket and recoating.

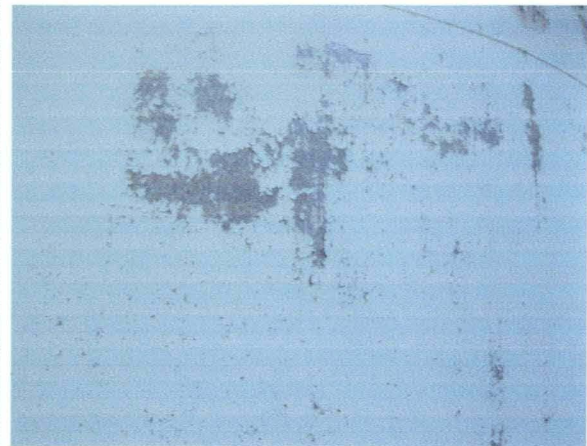
Wall Panel Condition

Coating Condition: Fair/Poor
 Corrosion Present? Y N
 Percentage: N/A
 Seams/Welds Condition: Excellent
 Oxidation Present? Y N
 De-lamination Present? Y N
 Dents Present? Y N
 Holes Present? Y N

Summary: The walls were found in fair condition with 50% de-lamination noted. Recommend recoating.

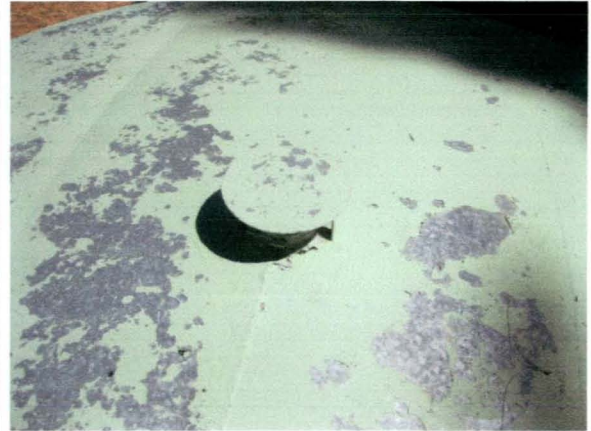
Vent Condition

Summary: The vent was found in good condition with a screen in place and corrosion noted. Recommend recoating.

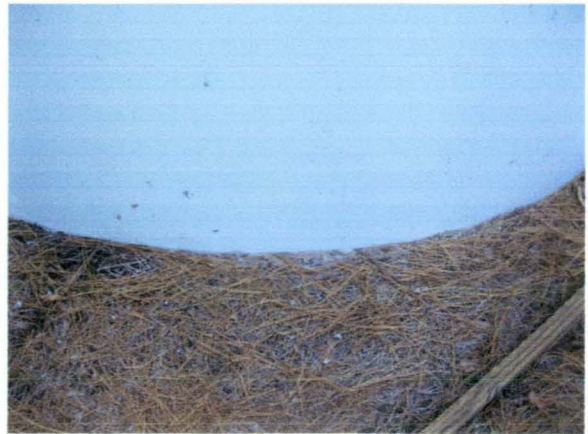
Foundation Condition

Summary: The foundation was found in excellent to good condition.

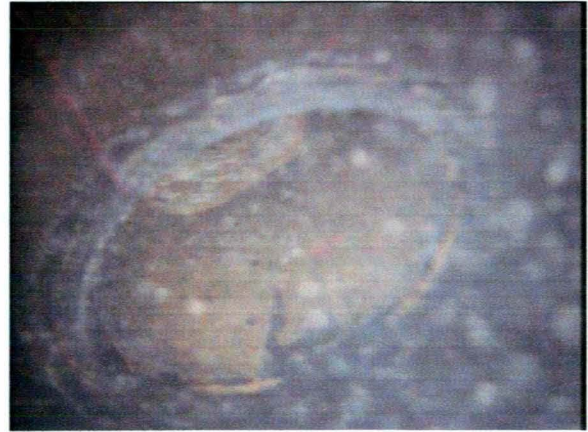
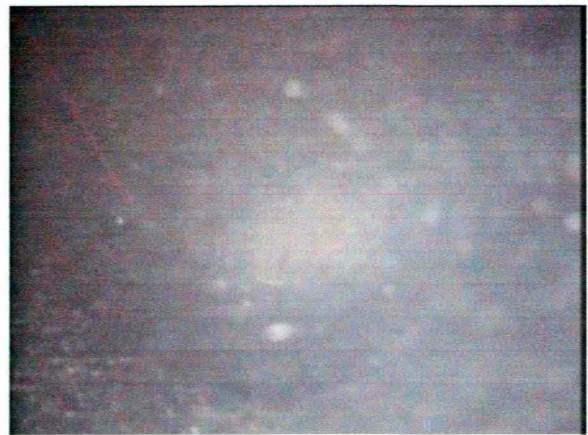
Inlet and Outlet Condition

Summary: The inlet and outlet were found in good condition with corrosion noted inside pipe.

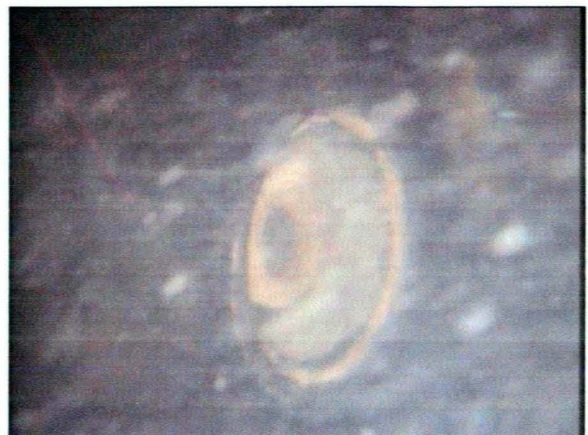
Drain Condition

Summary: The drain was found in good condition.

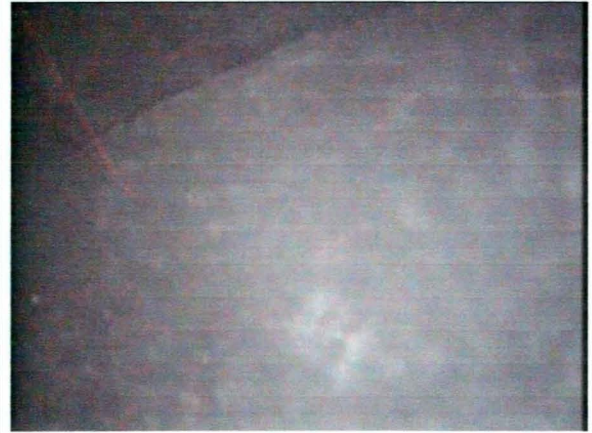
Wall Panel Condition

Summary: The walls were found in good condition. Between ¼ and ½ inch of manganese sediment was removed..

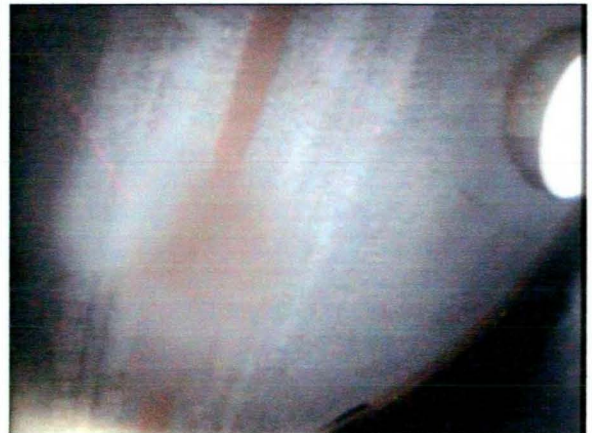
Roof Condition

Summary: The roof was found in good condition.

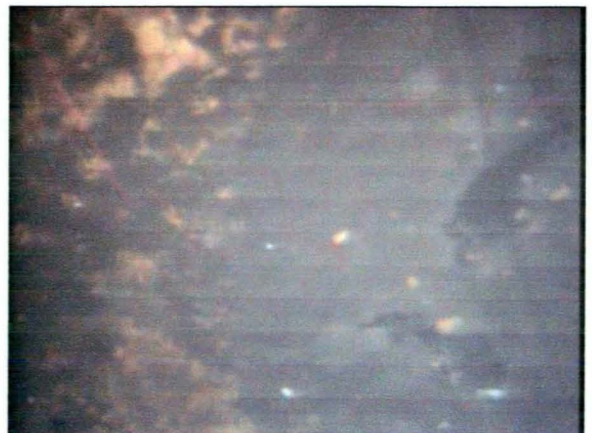
Floor Condition

Coating Condition: Fair
Welds/seam condition: Good
Corrosion Present? Y N
Percentage: N/A
Pitting noted in metal? Y N
Depth: N/A

Summary: The floor was found in good condition with 20% blistering noted. Between 2 and 3 inches of manganese sediment was removed.
