**Inspection Report for  
Odd Fellow Sierra Recreation Association  
Long Barn, CA**

**13 KG Steel on Grade  
Tank #4**

**Date Completed: July 4<sup>th</sup>, 2010**

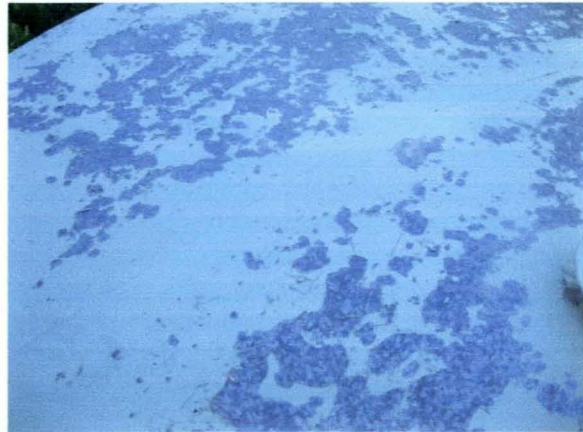
### Roof Condition

Coating Condition: Fair/Poor  
 Corrosion Present? Y  N   
 Percentage: N/A  
 Seams/Welds Condition: Excellent  
 Oxidation Present? Y  N   
 De-lamination Present? Y  N   
 Low Spots Present? Y  N   
 Holes in Roof? Y  N   
 Cathodic Protection Plates Present? Y  N   
 Sealed Edges: Y  N  NA   
 Loose Plates? Y  N  NA   
 Missing Plates? Y  N  NA

Summary: The roof was found in fair to poor condition with de-lamination noted. Recommend recoating.

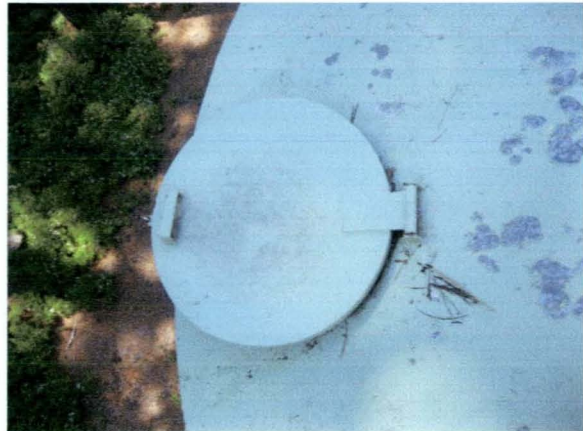
### Access Hatch Condition

Coating Condition: Fair/Poor  
 Corrosion Present: Y  N   
 Seams/Welds Condition: Excellent  
 Oxidation Present? Y  N   
 De-lamination Present? Y  N   
 Hatch Size: 18 inch round  
 Hatch Locked? Y  N   
 Hinge Condition: Good  
 Gasket Present? Y  N   
 Intact? Y  N  NA   
 Insects, dirt or debris present under hatch? Y  N

Summary: The hatch was found locked with no gasket present and in good condition with corrosion and de-lamination noted. Recommend installing a gasket and recoating.

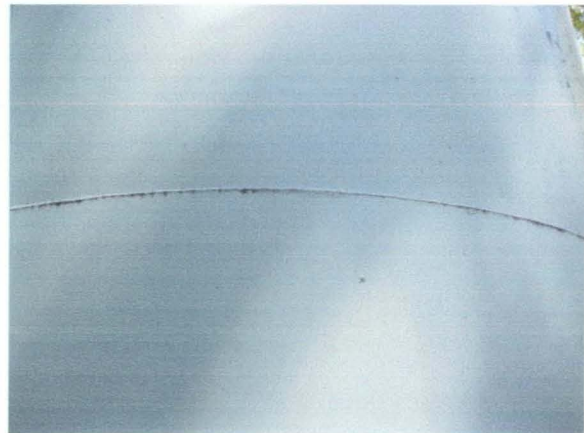
### Wall Panel Condition

Coating Condition: Fair/Poor  
 Corrosion Present? Y  N   
 Percentage: N/A  
 Seams/Welds Condition: Excellent  
 Oxidation Present? Y  N   
 De-lamination Present? Y  N   
 Dents Present? Y  N   
 Holes Present? Y  N

Summary: The walls were found in fair to poor condition with 50% de-lamination noted. Recommend recoating.

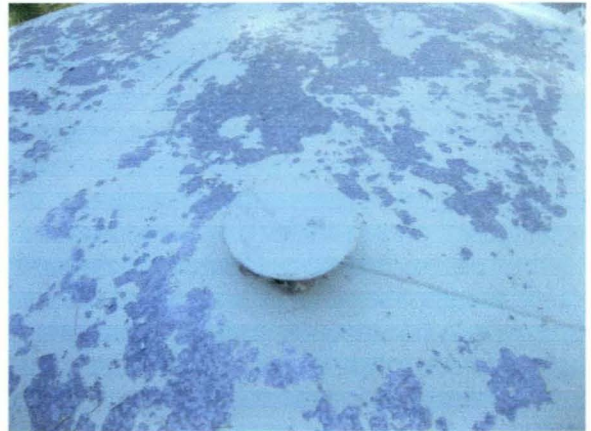
### Vent Condition

Coating Condition: Good  
Corrosion Present: Y  N   
Percentage: 5%  
Seams/Welds Condition: Good  
Oxidation Present? Y  N   
De-lamination Present? Y  N

Screen in Place? Y  N   
Condition: Good  
All Openings sealed? Y  N   
Cap Condition: Good

Summary: The vent was found in good condition with a screen in place and corrosion noted.

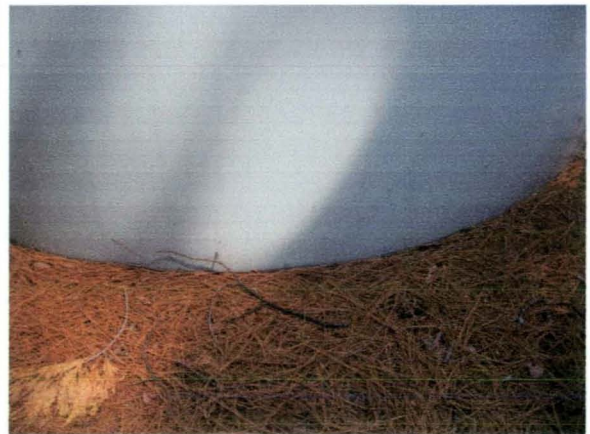
### Foundation Condition

Foundation Exposed? Y  N   
Anchor Bolts Present? Y  N   
Corrosion on Anchor Bolts Present? Y  N  NA   
Anchor Bolts Loose? Y  N  NA

Cracking Noted in Foundation? Y  N  NA   
Spalling Noted? Y  N  NA

Summary: The foundation was found in excellent to good condition.

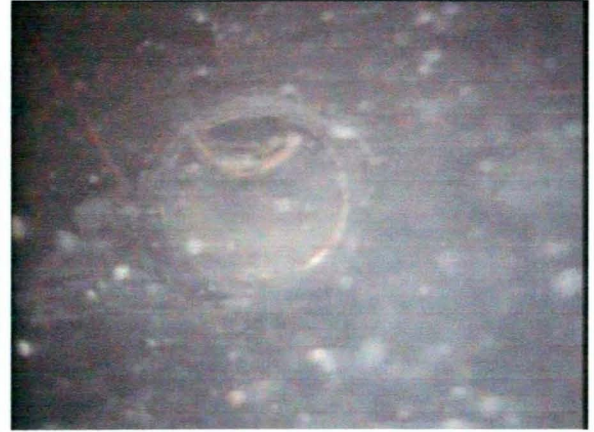
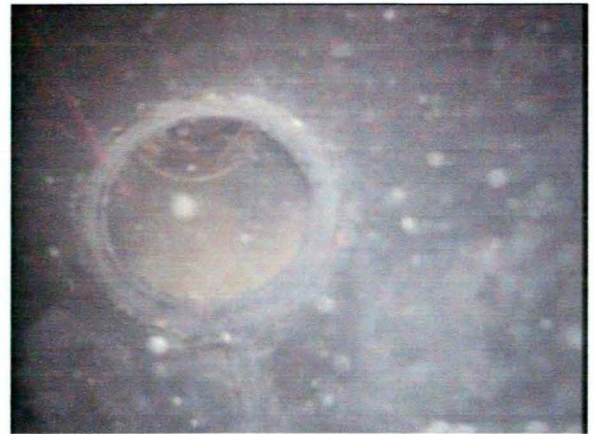
**Inlet and Outlet Condition**

Outlet location: 9 o'clock

Inlet Location: 6 o'clock

Coating Condition: Good

Weld/Seam Condition: Good

Summary: The inlet and outlet were found in good condition.

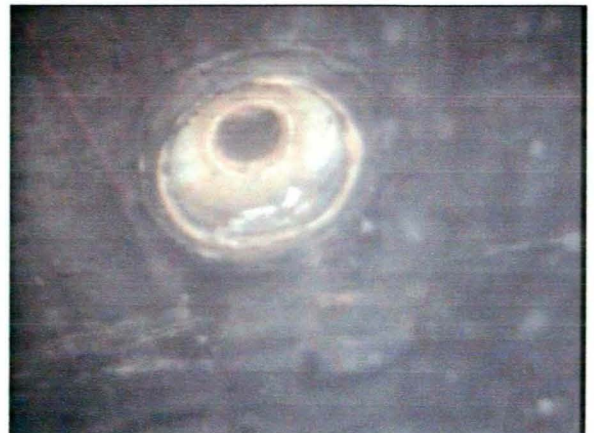
**Drain Condition**

Drain Location: 3 o'clock

Coating Condition: Good

Percentage: 5%

Summary: The drain was found in good condition with corrosion noted.

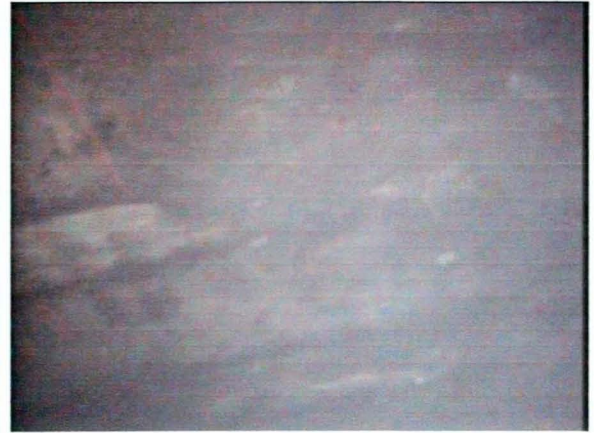
### Wall Panel Condition

Coating Condition: Good  
Welds/seam condition: Good  
Corrosion Present on panel? Y  N   
Percentage: N/A  
Pitting noted in metal? Y  N   
Depth: N/A

Summary: The walls were found in good condition. Between 1/4 and 1/2 inch of manganese sediment was removed.

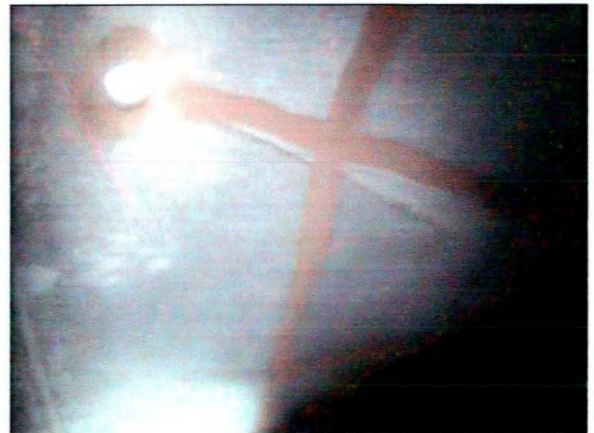
### Roof Condition

Coating Condition: Good  
Welds/seam condition: Good  
Corrosion Present on panels? Y  N   
Percentage: N/A  
Metal De-alloying noted? Y  N   
Percentage: N/A

Summary: The roof was found in good condition.

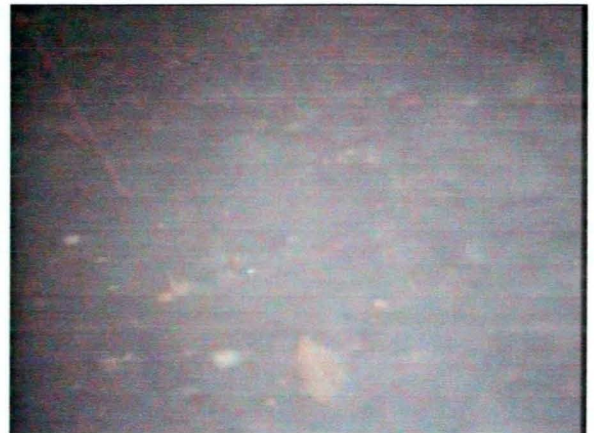
### Floor Condition

Coating Condition: Good  
Welds/seam condition: Good  
Corrosion Present? Y  N   
Percentage: N/A  
Pitting noted in metal? Y  N   
Depth: N/A

Summary: The floor was found in good condition. Between 2 and 3 inches of manganese sediment was removed.
