Inspection Report for
Odd Fellow Sierra Recreation Association
Long Barn, CA

210 KG Steel on Grade Tank

Date Completed: July 4th, 2010

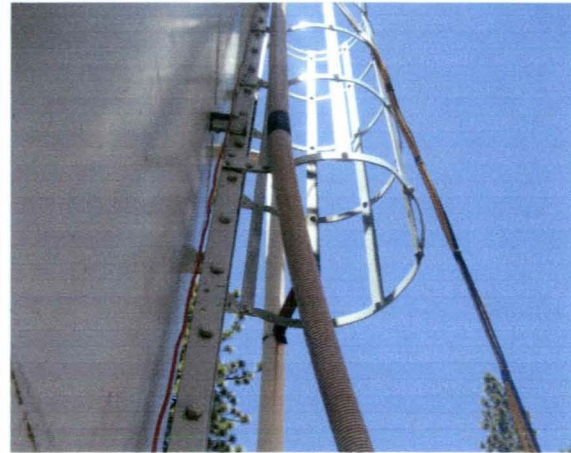
Access Ladder Condition

Ladder Type: Metal
 Coating Condition: Fair
 Corrosion Present? Y N
 Seams/Welds Condition: Good
 Oxidation Present? Y N
 De-lamination Present? Y N
 Stand Off Supports Condition: Good
 Safety Climb Type: Cage
 Safety Climb Condition: Good
 Is top of tank easily accessible? Y N
 Is the ladder and Safety Climb OSHA approved? Y N

Summary: The ladder was found secure, OSHA approved, and in good condition with 15% uniform surface corrosion and 15% de-lamination noted.

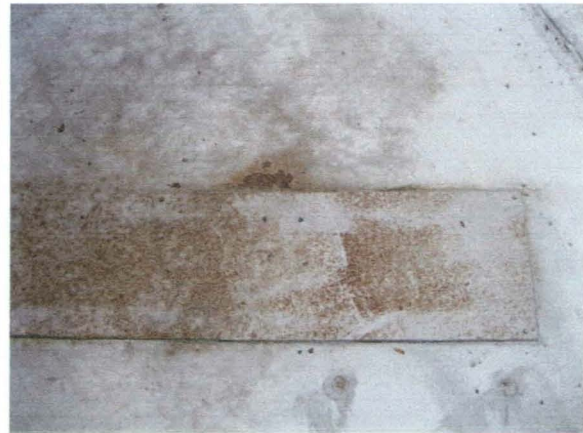
Roof Condition

Coating Condition: Good
 Corrosion Present? Y N
 Percentage: 5%
 Seams/Welds Condition: Good
 Oxidation Present? Y N
 De-lamination Present? Y N
 Low Spots Present? Y N
 Holes in Roof? Y N
 Cathodic Protection Plates Present? Y N
 Sealed Edges: Y N NA
 Loose Plates? Y N NA
 Missing Plates? Y N NA

Summary: The roof was found in good condition with corrosion, 10% blistering, 5% de-lamination, and 3 to 4 inches of pine needles noted.

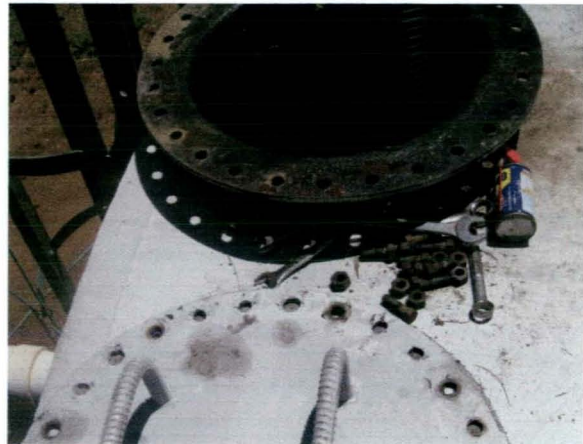
Access Hatch Condition

Coating Condition: Good
 Corrosion Present: Y N
 Seams/Welds Condition: Good
 Oxidation Present? Y N
 De-lamination Present? Y N
 Hatch Size: 26 inch round
 Hatch Locked? Y N (bolted)
 Hinge Condition: N/A
 Gasket Present? Y N
 Intact? Y N NA
 Insects, dirt or debris present under hatch? Y N

Summary: The hatch was found locked (bolted), with a gasket present and in good condition with corrosion and de-lamination noted. Recommend replacing the gasket. The bolts should also be replaced with stainless ones because the present ones are corroded and difficult to remove.

1. Install a new gasket on the access hatch.
2. Replace existing bolts with stainless ones to aid the removal of the hatch lid.
3. Install a finer, mesh screen over the existing one on the vent.
4. Schedule time, at the next cleaning, to repair the corrosion to the problem areas of the tank.
5. Schedule time to clean interior walls and support column.
6. Clean and inspect every 3-5 years per AWWA recommendations.

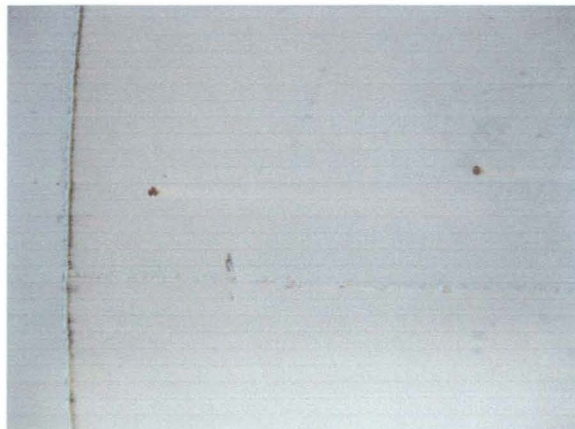
Wall Panel Condition

Coating Condition: Good
Corrosion Present? Y N
Percentage: 1%
Seams/Welds Condition: Good
Oxidation Present? Y N
De-lamination Present? Y N
Dents Present? Y N
Holes Present? Y N

Summary: The walls were found in good condition with corrosion, 3% blistering and 1% de-lamination noted.

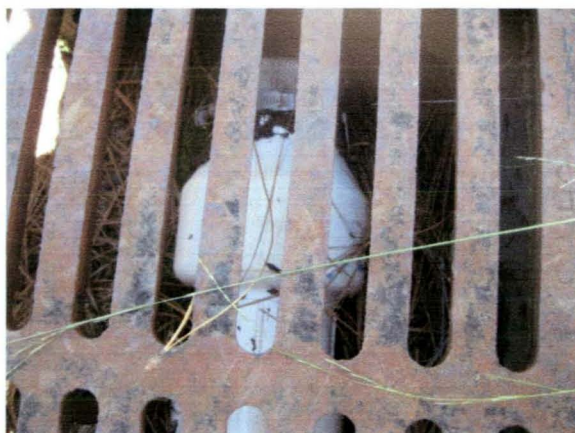
Overflow Structure Condition

Coating Condition: N/A (PVC)
Corrosion Present? Y N
Percentage: N/A
Seams/Welds Condition: N/A
Oxidation Present? Y N
De-lamination Present? Y N
Stand Off Supports Condition: Good
End Cap Present? Y N
Hinge and Cap Condition: Good
Screen Present? Y N
Condition: Good

Summary: The overflow was found in excellent condition with an end cap and screen present.

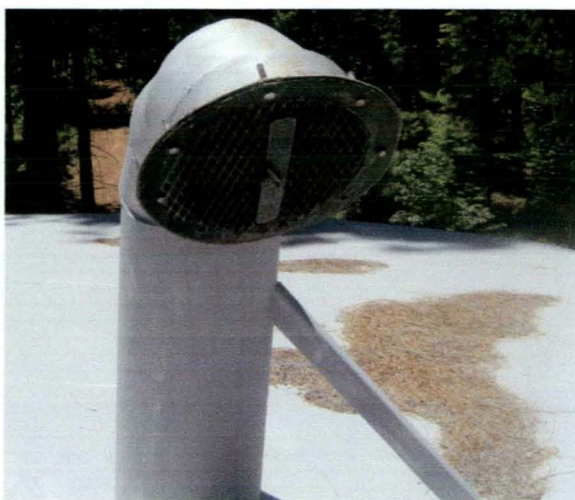
Vent Condition

Coating Condition: Good/Fair
Corrosion Present? Y N
Percentage: 5%
Seams/Welds Condition: Good
Oxidation Present? Y N
De-lamination Present? Y N

Screen in Place? Y N
Condition: Poor
All Openings sealed? Y N
Cap Condition:

Summary: The vent was found in good to fair condition with a screen in place and corrosion noted. Recommend installing a mess screen over the existing one.

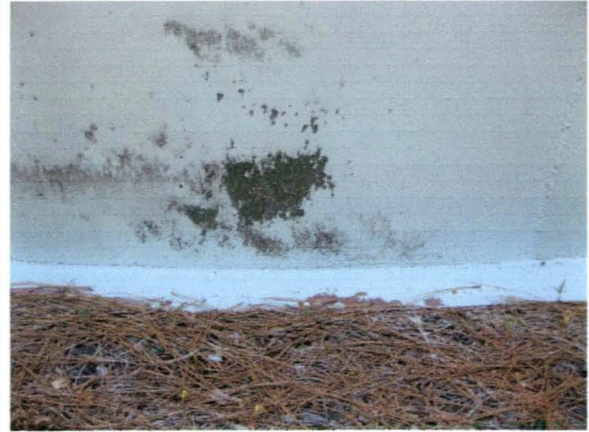
Foundation Condition

Foundation Exposed? Y N
Anchor Bolts Present? Y N
Corrosion on Anchor Bolts Present? Y N NA
Anchor Bolts Loose? Y N NA

Cracking Noted in Foundation? Y N NA
Spalling Noted? Y N NA

Summary: The foundation was found in excellent condition.

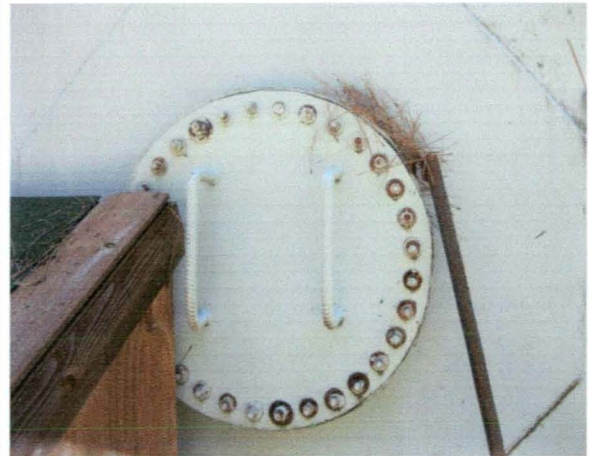
Manway Condition

Manway Location: 11:45 o'clock
Coating Condition: Good/Fair
Weld/Seam Condition: Good
Corrosion Present? Y N
Percentage: 5%
Pitting noted in metal? Y N
Depth: N/A

Summary: The manway was found secure and in good to fair condition with uniform surface corrosion noted on the hardware.

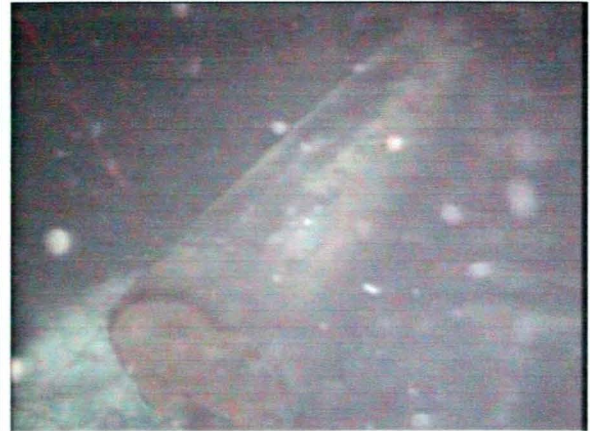
Inlet and Outlet Condition

Common Inlet/Outlet? Y N Location: 11:50 o'clock
If No:

Corrosion Present? Y N

Percentage: 3%

Summary: The common inlet/outlet was found in good condition with corrosion noted.

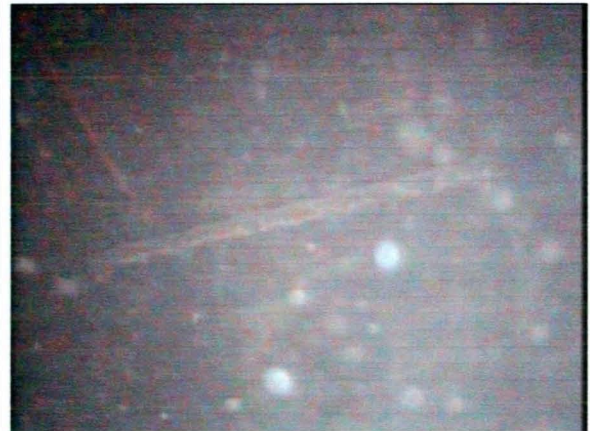
Ladder Condition

Ladder Location: 12 o'clock

Corrosion Present? Y N

Percentage: 2%

Summary: The ladder was found secure and in good condition with corrosion noted.

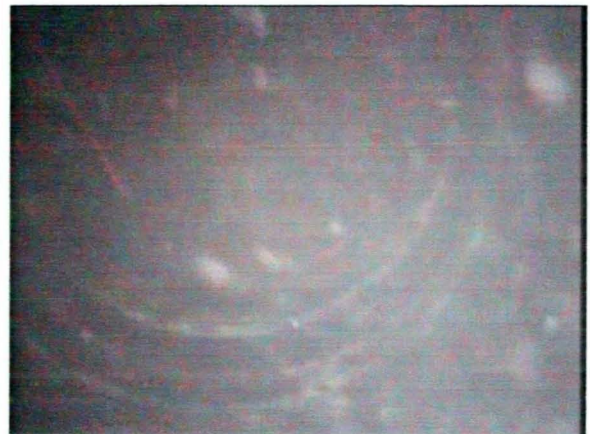
Manway Condition

Weld/Seam Condition: Fair

Corrosion Present? Y N

Percentage: 6%

Summary: The manway was found secure and in good to fair condition with corrosion starting on the seam and bolts.

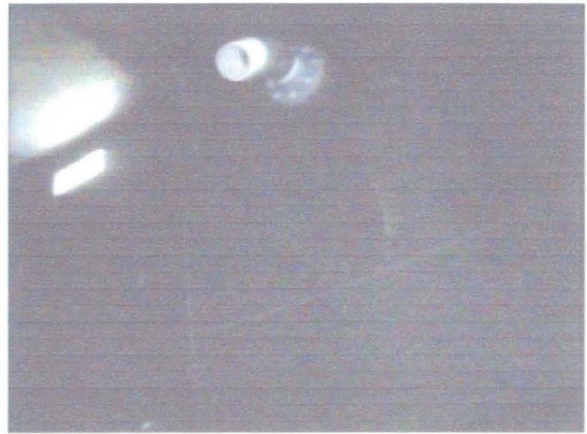
Overflow Condition

Overflow Location: 11:45 o'clock
Coating Condition: Good
Weld/Seam Condition: Good
Corrosion Present? Y N
Percentage: N/A
Pitting noted in metal? Y N
Depth: N/A

Summary: The overflow was found in good condition.

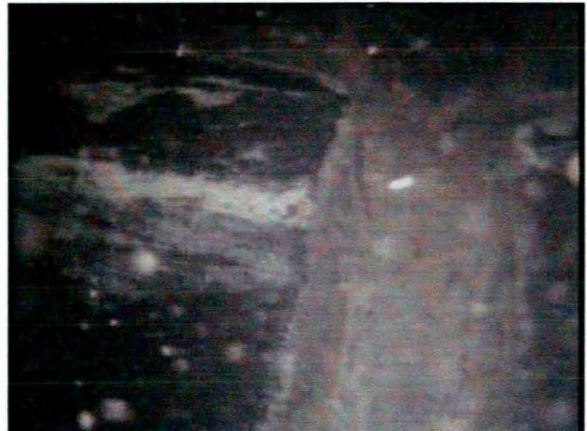
Drain Condition

Drain Location: 11:55 o'clock
Coating Condition: Good
Weld/Seam Condition: Good
Corrosion Present? Y N
Percentage: N/A
Pitting noted in metal? Y N
Depth: N/A

Summary: The drain was found in good condition.

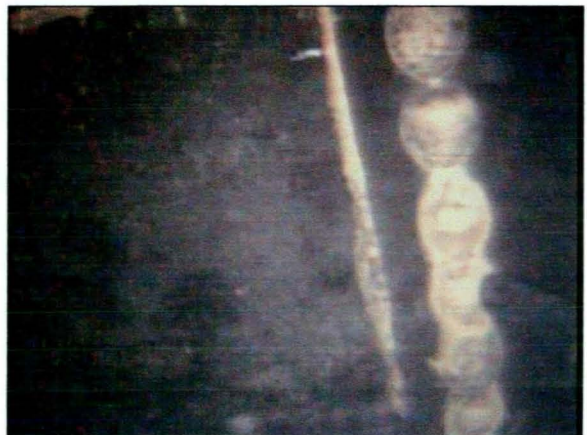
Wall Panel Condition

Coating Condition: Good
Welds/seam condition: Good
Corrosion Present on panel? Y N
Percentage: N/A
Pitting noted in metal? Y N
Depth: N/A

Summary: The walls were found in good condition with sediment and staining present.

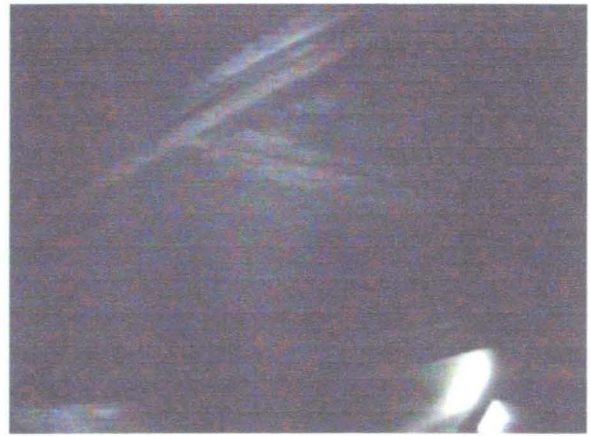
Roof Condition

Coating Condition: Good
Welds/seam condition: Fair
Corrosion Present on panels? Y N
Percentage: 10%
Metal De-alloying noted? Y N
Percentage: 5%

Summary: The roof was found in good to fair condition with uniform surface corrosion starting on the panels and de-alloying noted on the beams.

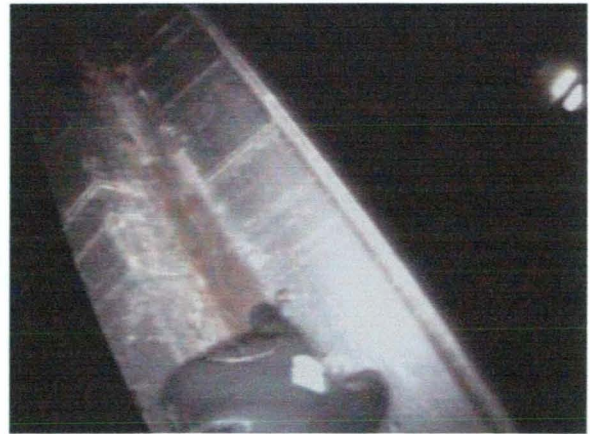
Support Column Condition

Coating Condition: Fair
Welds/seam condition: Good
Corrosion Present? Y N
Percent: 10%
Pitting noted in metal? Y N
Depth: N/A

Summary: The support column was found secure and in good to fair condition with corrosion noted and sediment adhering to the column. There is also de-alloying noted on the top three feet of the column.

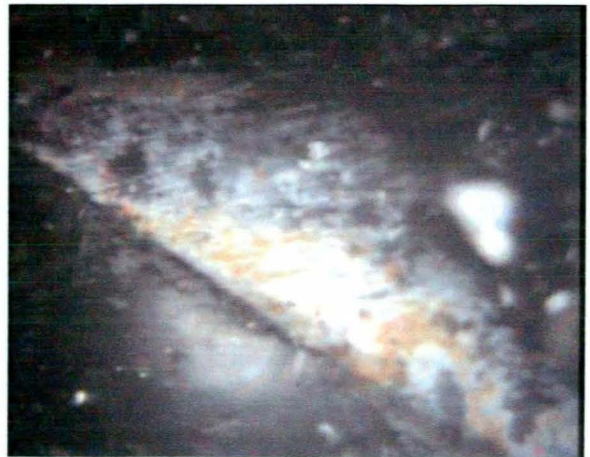
Floor Condition

Coating Condition: Good
Welds/seam condition: Good
Corrosion Present? Y N
Percentage: N/A
Pitting noted in metal? Y N
Depth: N/A

Summary: The floor was found in good condition. Between 4 and 8 inches of sediment was removed.
