Inspection Report for
Odd Fellow Sierra Recreation Association
Long Barn, CA

43 KG Steel on Grade Tank

Date Completed: July 4th, 2010

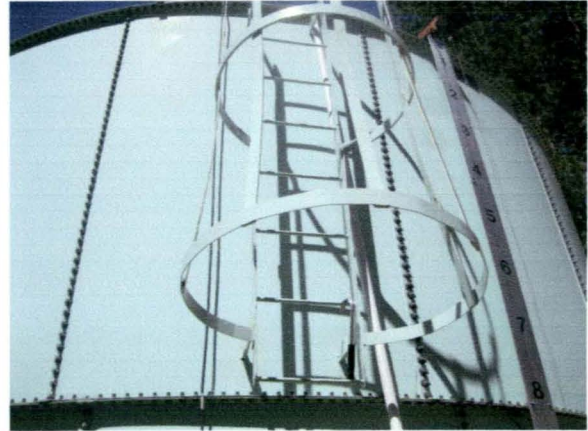
Access Ladder Condition

Ladder Type: Steel
 Coating Condition: Good
 Corrosion Present? Y N
 Seams/Welds Condition: Good
 Oxidation Present? Y N
 De-lamination Present? Y N
 Stand Off Supports Condition: Excellent
 Safety Climb Type: Cage
 Safety Climb Condition: Excellent
 Is top of tank easily accessible? Y N
 Is the ladder and Safety Climb OSHA approved? Y N

Summary: The ladder was found secure, OSHA approved and in good condition with corrosion and de-lamination noted. Recommend repairing the corrosion spots.

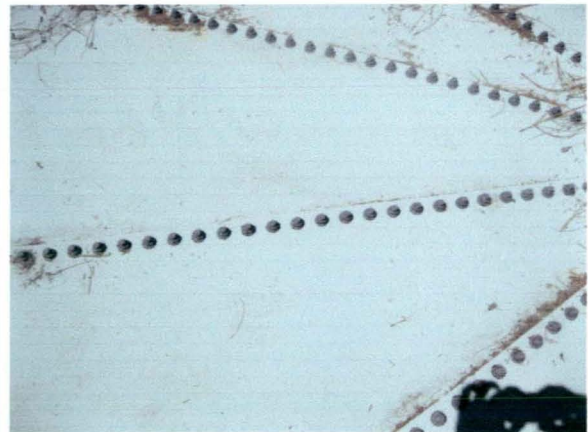
Roof Condition

Coating Condition: Good
 Corrosion Present? Y N
 Percentage: N/A
 Seams/Welds Condition: Excellent
 Oxidation Present? Y N
 De-lamination Present? Y N
 Low Spots Present? Y N
 Holes in Roof? Y N
 Cathodic Protection Plates Present? Y N
 Sealed Edges: Y N NA
 Loose Plates? Y N NA
 Missing Plates? Y N NA

Summary: The roof was found in good condition.

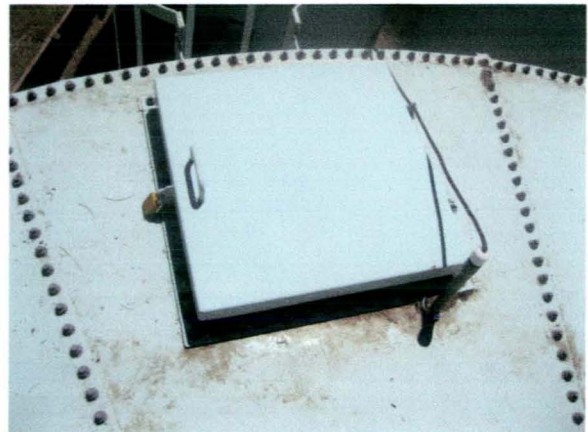
Access Hatch Condition

Coating Condition: Excellent/Good
 Corrosion Present: Y N
 Seams/Welds Condition: Excellent
 Oxidation Present? Y N
 De-lamination Present? Y N
 Hatch Size: 2 foot square
 Hatch Locked? Y N
 Hinge Condition: Excellent
 Gasket Present? Y N
 Intact? Y N NA
 Insects, dirt or debris present under hatch? Y N

Summary: The hatch was found locked with no gasket present and in excellent condition. Recommend installing a gasket.

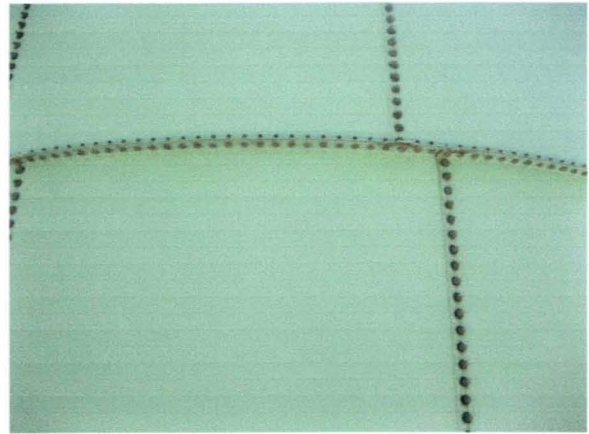
Wall Panel Condition

Coating Condition: Excellent/Good
 Corrosion Present? Y N
 Percentage: N/A
 Seams/Welds Condition: Excellent
 Oxidation Present? Y N
 De-lamination Present? Y N
 Dents Present? Y N
 Holes Present? Y N

Summary: The walls were found in excellent condition.

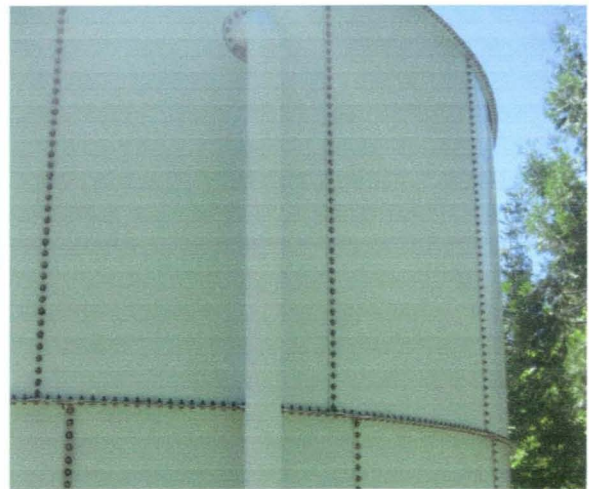
Overflow Structure Condition

Coating Condition: Excellent
 Corrosion Present? Y N
 Percentage: N/A
 Seams/Welds Condition: Excellent
 Oxidation Present? Y N
 De-lamination Present? Y N
 Stand Off Supports Condition: Excellent
 End Cap Present? Y N
 Hinge and Cap Condition: N/A
 Screen Present? Y N
 Condition: Excellent

Summary: The overflow was found in excellent condition with a screen in place.

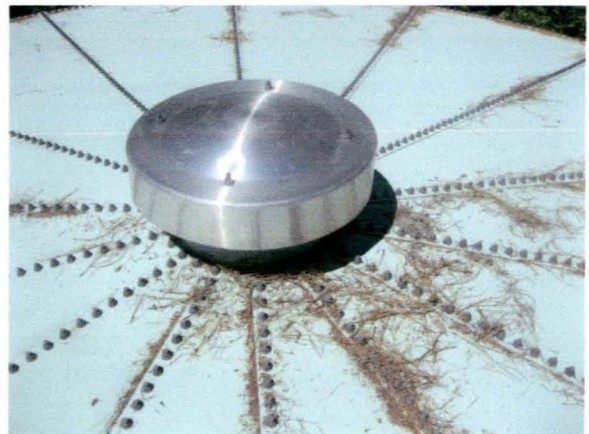
Vent Condition

Coating Condition: Excellent
 Corrosion Present: Y N
 Percentage: N/A
 Seams/Welds Condition: Excellent
 Oxidation Present? Y N
 De-lamination Present? Y N

Screen in Place? Y N
 Condition: Good
 All Openings sealed? Y N
 Cap Condition: Excellent

Summary: The vent was found in excellent condition with a screen in place.

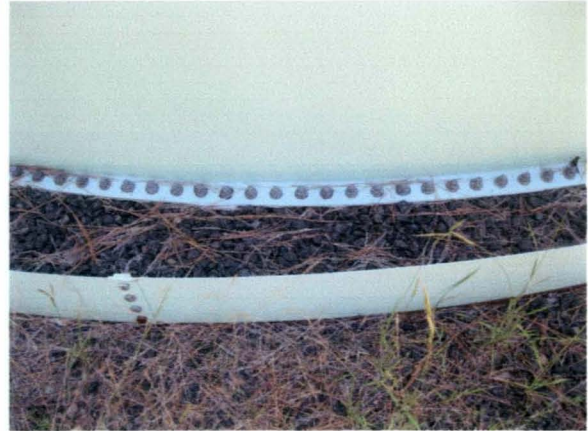
Foundation Condition

Foundation Exposed? Y N
Anchor Bolts Present? Y N
Corrosion on Anchor Bolts Present? Y N NA
Anchor Bolts Loose? Y N NA

Cracking Noted in Foundation? Y N NA
Spalling Noted? Y N NA

Summary: The foundation was found in excellent condition.

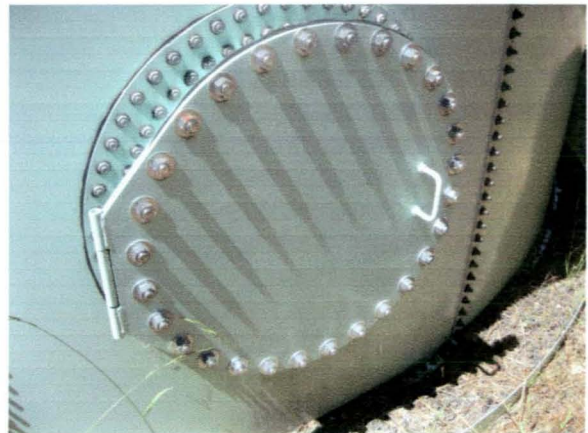
Manway Condition

Manway Location: 10:30 o'clock
Coating Condition: Excellent
Weld/Seam Condition: Excellent
Corrosion Present? Y N
Percentage: N/A
Pitting noted in metal? Y N
Depth: N/A

Summary: The manway was found secure and in excellent condition.

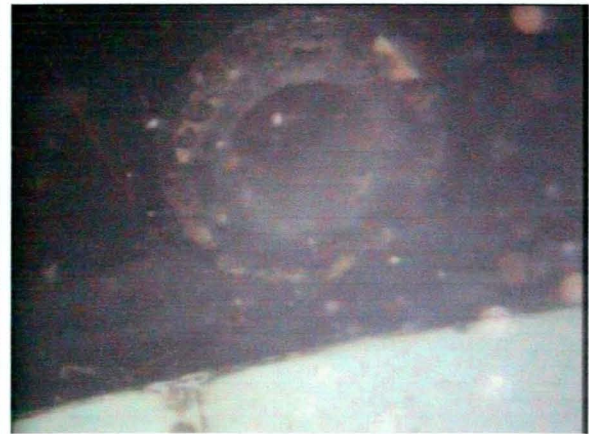
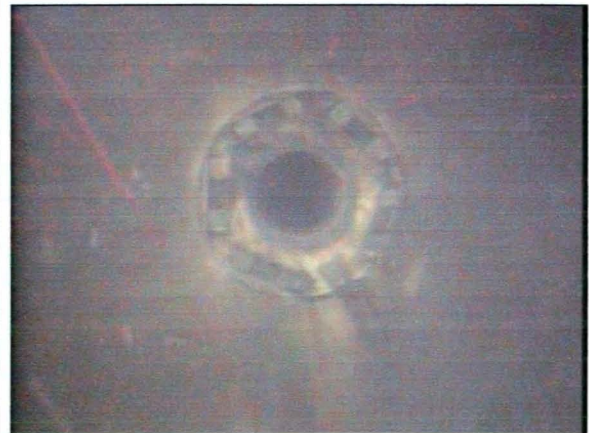
Inlet and Outlet Condition

Coating Condition: Good

Weld/Seam Condition: Fair

Percentage: 5%

Summary: The inlet and outlet were found in good condition with corrosion, pitting and noduling noted on the brackets and hardware.

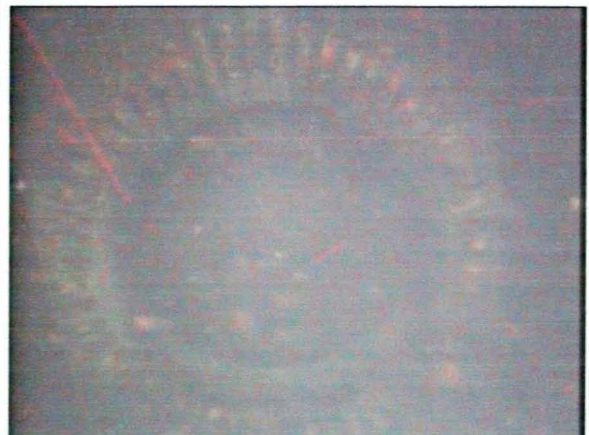
Manway Condition

Coating Condition: Good

Percentage: 10%

Summary: The manway was found in good condition with corrosion, pitting and noduling noted on the brackets and bolts.

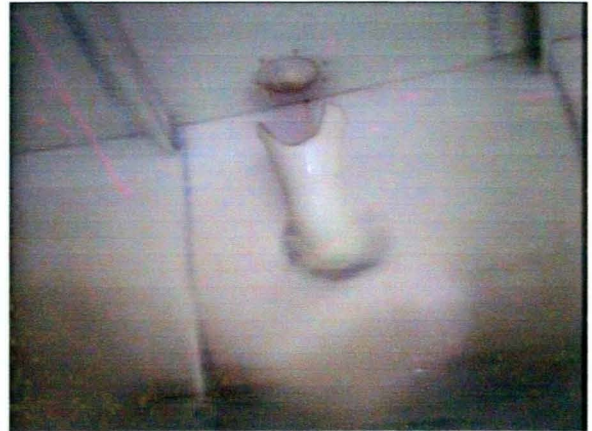
Overflow Condition

Overflow Location: 8 o'clock
Coating Condition: Good
Weld/Seam Condition: Good
Corrosion Present? Y N
Percentage: 10%
Pitting noted in metal? Y N
Depth: Unknown

Summary: The overflow was found in good condition with uniform surface corrosion, pitting and 2% de-alloying noted.

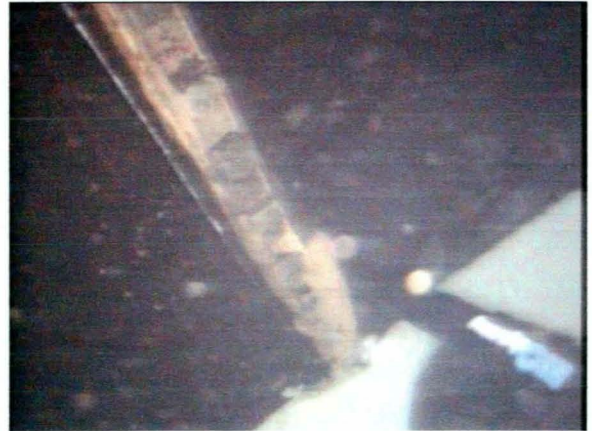
Wall Panel Condition

Coating Condition: See notes
Welds/seam condition: Good/Fair
Corrosion Present on panel? Y N
Percentage: N/A
Pitting noted in metal? Y N
Depth: N/A

Summary: The walls were found in good to fair condition with corrosion present on brackets and bolts at the seams. Heavy staining on the walls made it difficult to determine if corrosion was present.

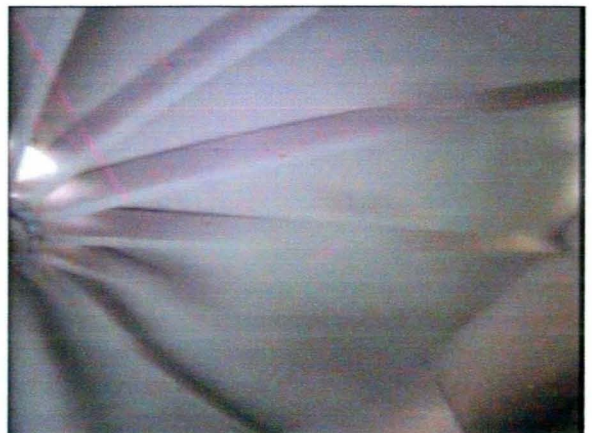
Roof Condition

Coating Condition: Good
Welds/seam condition: Good
Corrosion Present on panels? Y N
Percentage: 5%
Metal De-alloying noted? Y N
Percentage: N/A

Summary: The roof was found in good condition with corrosion noted on the support beams.

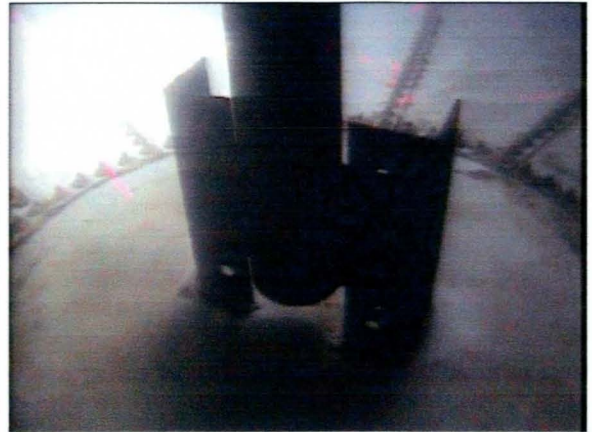
Support Column Condition

Coating Condition: Good
Welds/seam condition: Excellent
Corrosion Present? Y N
Percent: 5%
Pitting noted in metal? Y N
Depth: N/A

Summary: The support column was found secure and in good condition with corrosion and staining noted. There is also uniform surface corrosion on the bolts at the base of the column.

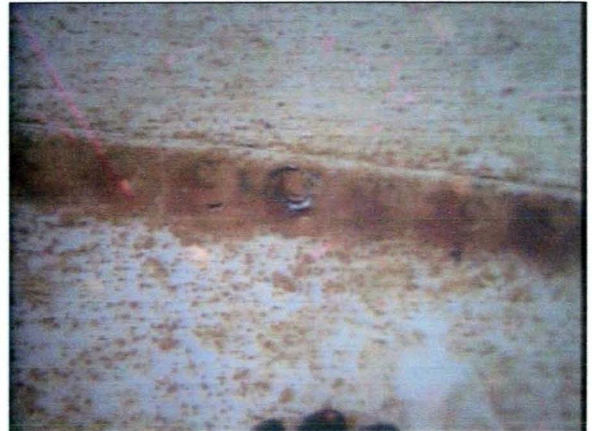
Floor Condition

Coating Condition: Excellent
Welds/seam condition: Fair
Corrosion Present? Y N
Percentage: 5%
Pitting noted in metal? Y N
Depth: Unknown

Summary: The floor was found in good condition with uniform surface corrosion and noduling present on the nuts and bolts at the seams of the panels. Between 2 and 3 inches of manganese sediment was removed.
