Sierra Park Water Company Water System Condition Assessment

Report

December 2016

BLACK WATER CONSULTING ENGINEERS, INC.
605 Standiford, Suite N
Modesto, CA 95350
(209) 322-1817

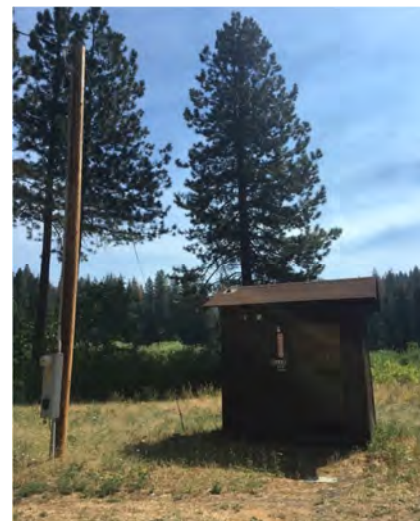
Figure 2-2 - Well Site No. 5

2.2.1.1 Well Site No. 5

Well site No. 5 is located on Jordan Way West. Well No. 5 was drilled in 1986. The total well depth is 350 feet. The borehole contains a 12-inch diameter, 10-inch diameter, and 7-inch diameter steel casing from 0 to 34 feet, 0 to 86 feet, and 0 to 146 feet, respectively. The 7-inch diameter casing is perforated from 95 feet to 140 feet. The well has a cement and bentonite annular seal to a depth of 90 feet and a gravel pack from 90 to 145 feet.

The well, discharge piping, and electrical controls are housed in a permanent wood framed building.

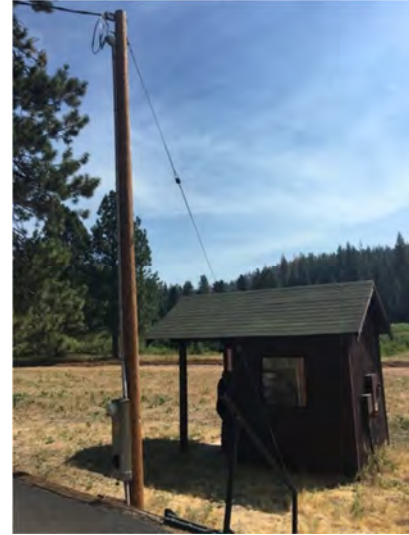
Figure 2-4 - Well No. 6 Site

Well site No. 6 is located on Jordan Way West, just south of Well Site No. 5. Well No. 6 was drilled in 1996. The total well depth is 403 feet. The borehole contains a 12-inch diameter and an 8-inch diameter steel casing from 0 to 55 feet and 0 to 78 feet, respectively with no perforations. The well has a cement annular seal to a depth of 50 feet and no gravel pack. The well completion report is included in Appendix D.

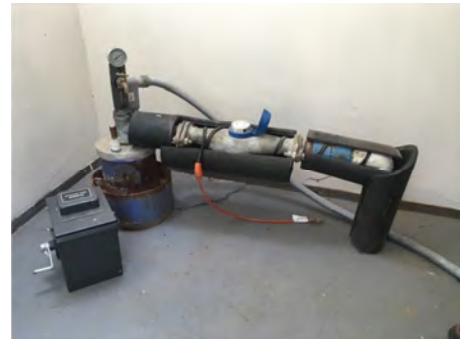
Figure 2-5 - Well No. 6

The well is equipped with a Berkeley Model 6T15-115 submersible pump and 15-HP constant speed motor capable of pumping approximately 100 gpm. The well discharge piping includes a check valve and flow meter. The well is also equipped with a 3/4-inch diameter sounding tube. Power supply to the site is 230-V, 3-Phase. The pump was installed in 2014 when there were mechanical issues with fuses blowing at the site that was attributed to the well pump.

Well No. 6 is operated manually, in alternating sequence with Well No. 5. The well is equipped with a run timer to allow the operator to schedule operation of the well to maintain tank levels, as needed. Water is distributed to the system via a 6-inch diameter water main.

Recent water quality violations for exceedance of secondary MCL of 0.05 mg/L for manganese occurred during one reporting quarter in 2014, all reporting quarters in 2015, and one reporting quarter in 2016.

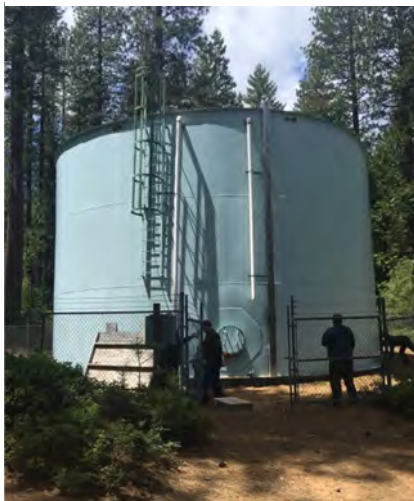
Figure 2-7 - 210,000 gal Storage Tank

There are a total of six storage tanks at two tank sites with a combined storage volume of 303,000 gallons which provides working pressures for the system based on tank levels. Water supplied from the wells are pumped through the distribution system and stored in the tanks. The 210,000 gallon storage tank is located off Isaac Road at the southeast end of the distribution system. The other tank site is located off David Drive at the northeast end of the distribution system and has five storage tanks, one 43,000 gallon storage tank and four 12,500 gallon storage tanks. Table 2-2 presents a summary of the storage tank data.

In 2010, all storage tanks were inspected and the findings were reported in separate reports for each tank and all recommended maintenance improvements were completed in July 2015. The storage tanks were recently inspected in 2016 and no additional maintenance was recommended. Appendix E includes the 2010 tank inspection reports.

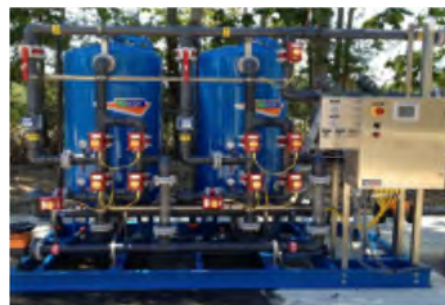
Figure 4-1 - Typical Packaged Oxidation/Filtration Treatment System (AdEdge)

Oxidation/filtration technology utilizes an oxidant and media to oxidize and remove iron and manganese. Packaged treatment systems equipped with chlorine injection and pressure vessels with filtration media to facilitate oxidation and filtration in a single step without long residence times area available. Advantages to packaged treatment plants include small footprint area and a complete treatment system with instrumentation and controls and backwash recycle options. All treatment equipment can be housed in a secure building. Capital costs are considerably higher than other treatment methods, but overall system maintenance costs are low. However, regular disposal of sludge byproduct is required and recommended at least every two to three months. The sludge material is non-hazardous and can be disposed via landfill.

Figure 4-1 shows a typical packaged oxidation/filtration treatment system, and Figure 4-2 shows a process flow schematic for the treatment system.

The packaged treatment system is the recommended option for effective removal of iron and manganese from the groundwater wells in order to comply with regulatory requirements for water quality. Treatment is typically located near the well head. However, if visual aesthetics are a priority to the community, locating a new building near the existing well sites may be undesirable. The final location of the treatment system will be determined during the planning and design phase. The addition of a treatment system will require amendment to the existing Permit. On-site treatment is recommended as the most effective way to reduce iron and manganese if groundwater continues to be the sole water supply source for the water system.

A packaged oxidation and filtration treatment system is recommended to provide removal of iron and manganese in the groundwater supply sources. The treatment system will be designed for a maximum capacity of 100 gpm (capacity of the highest producing well, Well No. 6). The proposed packaged treatment system is the AdEdge AD26 Oxidation Filtration System. The proposed packaged system includes the following:
